PUMP CASE EROSION DAMAGE REPAIR IN GRAVEL MINE

Hungary, Gravel mine

2021.02.20

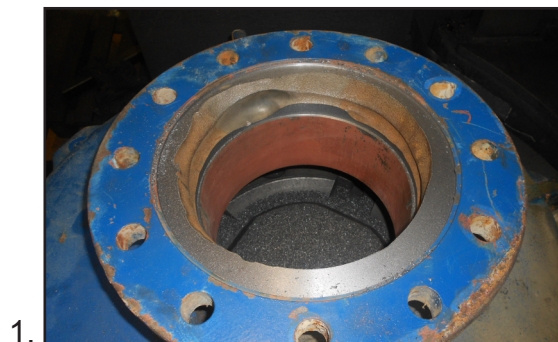
The customers Warman WGR200 suffered from erosion because of the failure of the rubber lining the entrapped solid in the flow found route to the casing surface. The casing material wore until leakage.

1. Defective casing
2. Defective area
3. Defective area after sand blasting
4. Finished application with 1321 top-coat
