BELZONA HELPS A MANUFACTURER OF AEROPLANE COMPONENTS

CUSTOMER
Tunisia

APPLICATION DATE
Jun-21

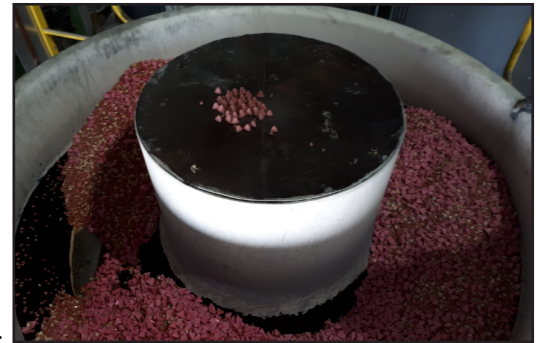
APPLICATION SITUATION
During inspection, localised damage to the rubber linings caused by wear and abrasion was noted

PROBLEM
Severely damaged rubber linings. Presence of three cracks after surface preparation.

1. Damaged rubber linings
2. Cracks repair with Belzona 1111 (Super-Metal) and Belzona 9341 (Reinforcement Tape)
3. Application of first coat of Belzona 2141 (ACR-Fluid Elastomer) with the Reinforcement Tape Belzona 9341
4. Completed application
