# Belzona Restores Seawater Cooling Pump Impeller

ID: 10016

Industry: Marine  
Application: CEP-Centrifugal Pumps  
Substrate: Bronze  
Products: Belzona 1111 (Super Metal), Belzona 1321 (Ceramic S-Metal)

Customer Location: Durban - South Africa  
Application Date: September 2025

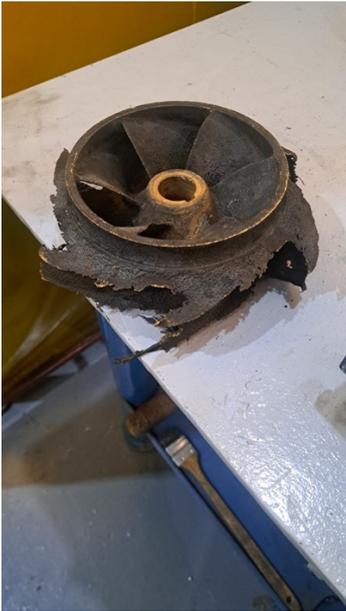
Customer had an emergency docking and sourcing a new impeller would have taken 6 to 8 weeks delivery. Impeller was severely eroded and required urgent rebuilding and coating protection from salt water as this was the vessel's sea water cooling pump.

Damaged Impeller Received From Customer.

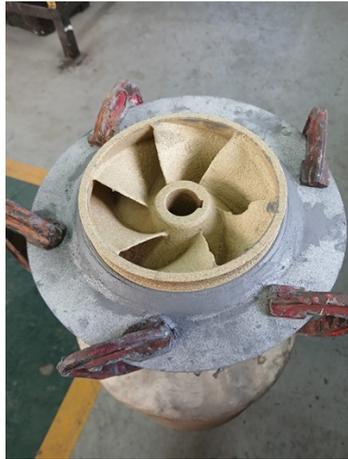
Stainless Plates Cold bonded, Clamped And Shaped To Rebuild Lost Areas.

1. Received impeller, washed with SaltAway and grit blasted clean for inspection and measurement purposes.
2. Top plate made and formed to 260mm OD with ID to suit suction wear-ring OD.
3. Plate and impeller re-blasted prior to being bonded in place with Belzona 1111.
4. A further bottom plate was cut to 260 OD with an ID to suit existing out vanes.
5. Plate and impeller grit blasted and plate bonded in place with Belzona 1111.
6. Sheet metal cut and folded over to rebuild width, length and thickness for damaged vanes rebuild.
7. After blasting, the 6 new vanes bonded in position and the edges and surrounding impeller metal smoothed out with Belzona 1111 and allowed to cure.

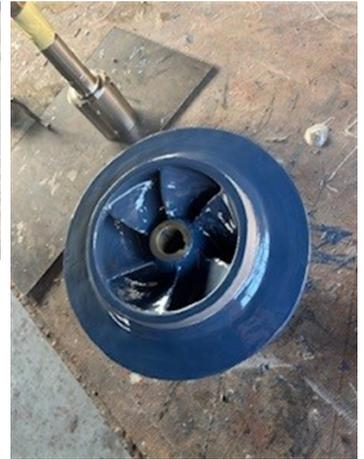
Impeller Completed And Restored.

8. The complete impeller was re-blasted and 2 coats of Belzona 1321 applied throughout.
9. The suction wear-ring was then over-built with Belzona 1111 for machining to correct OD by MSC Technical prior to balancing.
10. After balancing, touch-up undertaken where the balancing damaged the Belzona 1321 coating.
