Roof flashing cover upgraded with Belzona

ID: 10040

Industry: *General Industry* Customer Location: *Mansfield*
Application: *RPA-Roof Problem Areas* Application Date: *September 2022*
Substrate: *Carbon steel*
Products: *Belzona 3131 (WG Membrane), Belzona 3921 (GSC Surface Conditioner)*

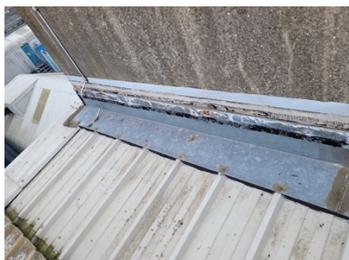
A roof flashing had become detached from the concrete side wall, leading to water ingress issues between the roof and the side concrete structure.

Original problem area showing leaking flashing baffle.

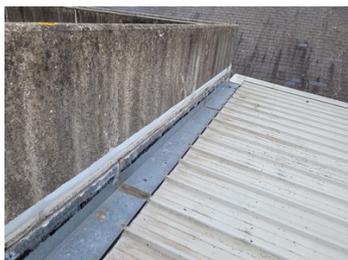
Flashing not sealing between concrete face and over existing roof.

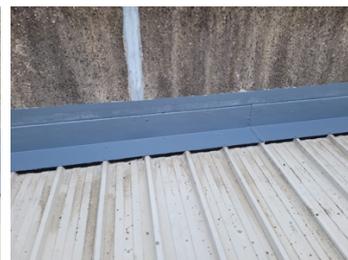
Face on view of the complete Belzona 3131 system repair.

The galvanised steel was cleaned and degreased, prior to having 1 coat of Belzona 3921 General Surface Conditioner applied. 2 coats of Belzona 3131 were applied with a layer of Belzona 9361 reinforcing sheet to give it additional strength.
