# Pipe Repair Using Belzona 1161 and SuperWrap II

ID: 10239

Customer Location: Seattle  
Application Date: June 2025

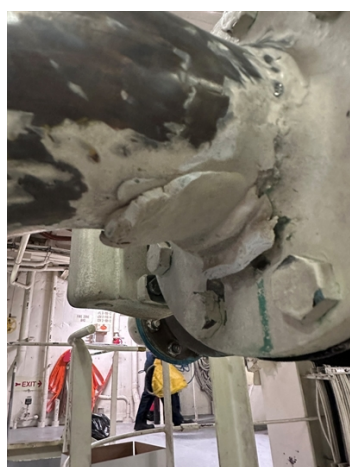
A copper-nickel main motor cooler pipe developed an active leak while the vessel was at sea. The 3-inch diameter pipe had experienced through-wall corrosion, resulting in a breach that compromised cooling system integrity and threatened continued operation of the main motor. A temporary repair was performed at sea to stop the leak and get the vessel back underway. Copper-nickel piping in seawater cooling service is subject to accelerated corrosion driven by flow velocity, turbulence, and the corrosive marine environment, and once wall loss progresses to a through-wall failure, the risk of uncontrolled flooding, equipment damage, and loss of propulsion capability increases significantly. While the temporary repair restored immediate operability, it was not a long-term solution, and a permanent engineered repair was required once the vessel reached port to restore full structural integrity and pressure rating to the pipe.

Temporary Repair Made at Sea Surface Prep

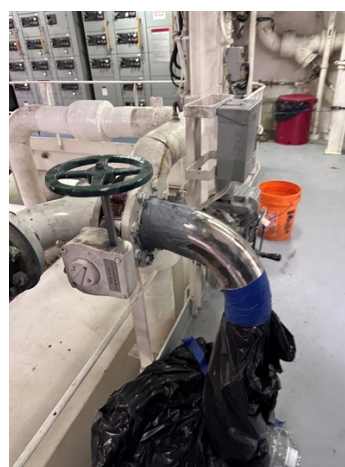
Belzona 1161 Being Applied

The temporary at-sea repair was removed and the damaged area of the 3-inch copper-nickel pipe was cleaned and prepared using mechanical methods including rotary tools and flap discs to remove corrosion products, expose bright base metal, and establish an adequate surface profile for adhesion. The prepared area was solvent cleaned to remove any residual contaminants. Belzona 1161 (Super UW-Metal) was mixed and applied to the damaged section of the pipe to fill the through-wall defect, rebuild lost wall thickness, and create a smooth, uniform surface geometry suitable for overwrapping. Once the Belzona 1161 filler had been shaped and the substrate contour restored, the Belzona 1984 (SuperWrap II) composite system was applied over the repair area. Belzona 9381 reinforcement sheet was saturated with the Belzona 1984 resin and wrapped around the pipe in accordance with Belzona's Instructions for Use (IFU's), with Belzona 9382 release film applied as the final outer layer. The total application time was approximately two hours. The completed repair was allowed to cure for four days before the system was returned to service.

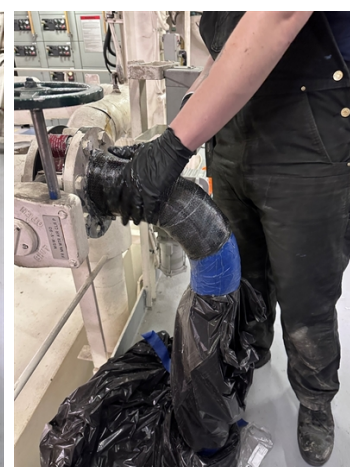
SuperwrapII being applied
