I.D. FAN SHAFT REPAIRED IN SITU WITH BELZONA

ID: 1034

Industry: Power
Application: MPT-Mechanical Power Transmission

Customer Location: Power plant, Bulgaria
Application Date: May 2006

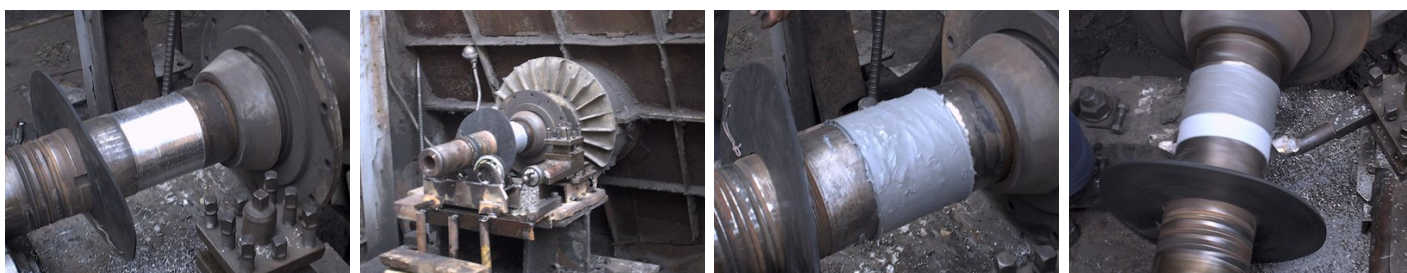
Shaft damaged at bearing location by seized bearing.

- * Damaged area of the shaft undercut ,
- * All machining and application work carried out on site by using fan rotation and small hand lathe ,
- * Belzona® 1111 applied ,
- * Machining to the final diameter ,

Application was carried out in accordance with Belzona Know-How System Leaflet MPT-1. The journal was prepared and machined in situ using the draft of the gases to rotate the shaft. Simple small lathe was mounted to machine the area to desired diameter.

Belzona used to rebuild the original dimensions of the shaft without dismatling the fan. Belzona returned the equipment in service with minimal production down time. This procedure has become standard for emergency shaft repairs in the plant.
