BELZONA GIVES LIFE TO PUMP

ID: 1096

Customer Location: Power Plant, Russia
Application Date: June, 1998

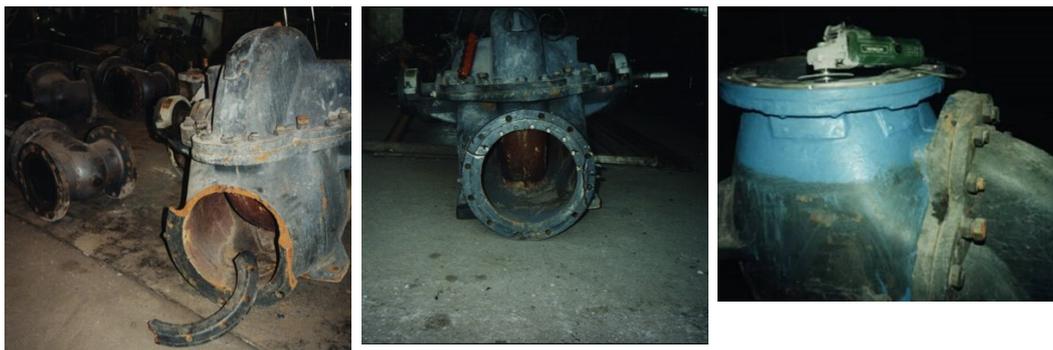
Due to inaccurate assembling of suction pipe and pressure pipe both suction and pressure flanges were torn off the pump body.

* Pump lost its flanges , * Flanges are in place again with Belzona® 1111 , * The pump is restored ,

Flanges were rebuilt from pieces. All cracks in the pump casing were detected, cut out and fixed in accordance with Belzona Know-How System Leaflet ENC-1. Steel reinforcing plates were made. Flanges and reinforcing plates were fixed with Belzona® 1111 and secured with screws.

Repair work took 36 hours. Pressure testing of the pump at test bench showed full impermeability. Put back into operation and worked more than 2 years until planned replacement. With Belzona solution the customer avoided serious losses from new pump purchase and long downtime. Full repair cost only 10% of new pump price.
