BELZONA BELT REPAIR KEEPS MINE PRODUCING

ID: 1229

Application: SHM-Solids Handling Machinery

Substrate: Rubber Conveyor Belt

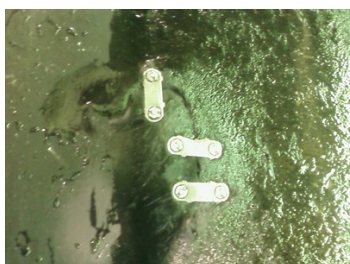
A large rock found its way between the drive roller & the belt, resulting in extensive damage to belt. Minimizing downtime was crucial!

* Attempts to prevent belt from tearing further Belt cleaned and undercut Former with weights in place to form repair smooth and flush with belt surface Repair completed ,

Application was carried out in accordance with Belzona Know-How System Leaflet SHM-1. The belt was cleaned, degreased, and undercut 1/4" x 3" wide on all sides of damaged area. Reinforcement tape was embedded in the Belzona® 2211 for additional strength.
