BELZONA BELT REPAIR KEEPS MINE PRODUCING

Customer Location: Mine, Central Missouri

Application: SHM-Solids Handling Machinery

Substrate: Rubber Conveyor Belt

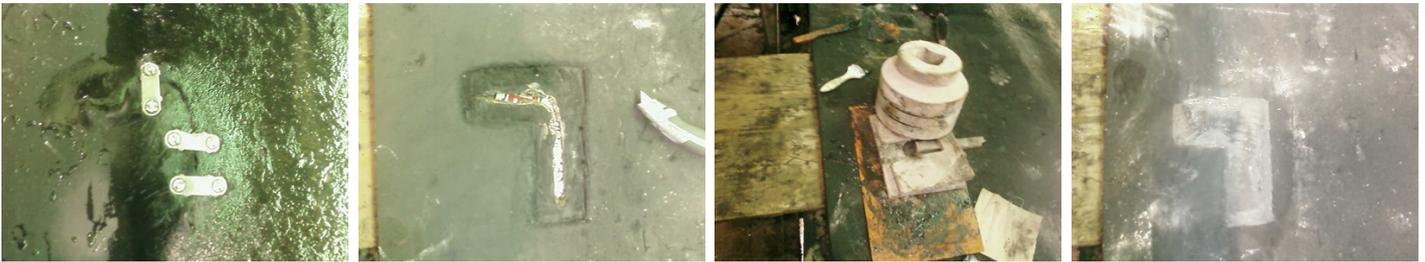
A large rock found its way between the drive roller & the belt, resulting in extensive damage to belt. Minimizing downtime was crucial!

* Attempts to prevent belt from tearing further Belt cleaned and undercut Former with weights in place to form repair smooth and flush with belt surface Repair completed ,

Application was carried out in accordance with Belzona Know-How System Leaflet SHM-1. The belt was cleaned, degreased, and undercut 1/4" x 3" wide on all sides of damaged area. Reinforcement tape was embedded in the Belzona® 2211 for additional strength.
