BELZONA BELT REPAIR KEEPS MINE PRODUCING

ID: 1229

Substrate: Rubber Conveyor Belt
Products: * Belzona® 2211 (MP Hi Build Elastomer) ,

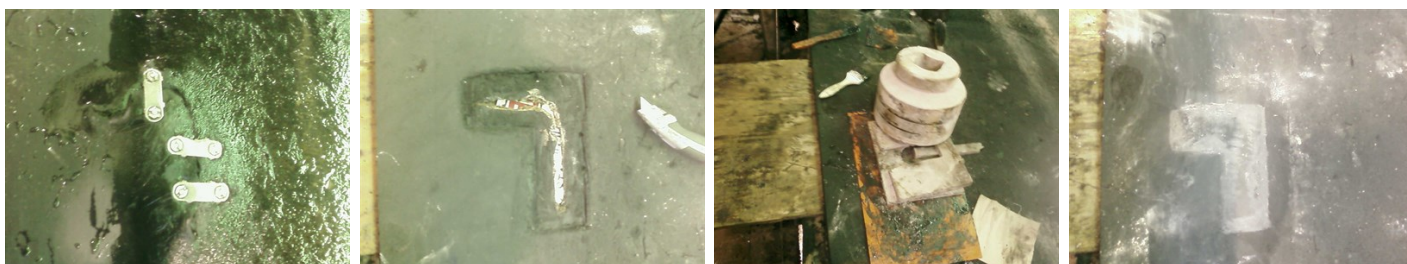
A large rock found its way between the drive roller & the belt, resulting in extensive damage to belt. Minimizing downtime was crucial!

* Attempts to prevent belt from tearing further Belt cleaned and undercut Former with weights in place to form repair smooth and flush with belt surface Repair completed ,

Application was carried out in accordance with Belzona Know-How System Leaflet SHM-1. The belt was cleaned, degreased, and undercut 1/4" x 3" wide on all sides of damaged area. Reinforcement tape was embedded in the Belzona® 2211 for additional strength.
