BELZONA REPAIR TO DIAPHRAGMS IN STEAM TURBINE

ID: 126

Customer Location: Power Plant in Indianapolis
Application Date: February 1995

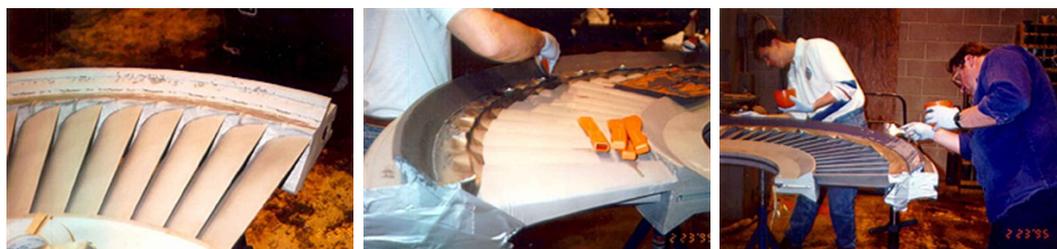
Severe erosion/ corrosion of the turbine diaphragms in the the latter stages of the low pressure side of the steam turbine. This had been caused by many years exposure to saturated steam and had resulted in a decrease in efficiency in the turbine.

- * Erosion damage on the diaphragm ,
- * Application of Belzona® 1311 to restore profiles ,
- * Application of Belzona® 1391 underway ,

Modified versions of Belzona Know-How Leaflets CEP-5 and CEP-3. Belzona® 1311 was used to rebuild the damaged areas. Sites rebuilt were then treated with two coats of Belzona® 1391.
