CAVITATION DAMAGED IMPELLER REPAIRED WITH BELZONA

ID: 1260

Customer Location: Water Treatment Plant, Virginia.
Application Date: April 2008

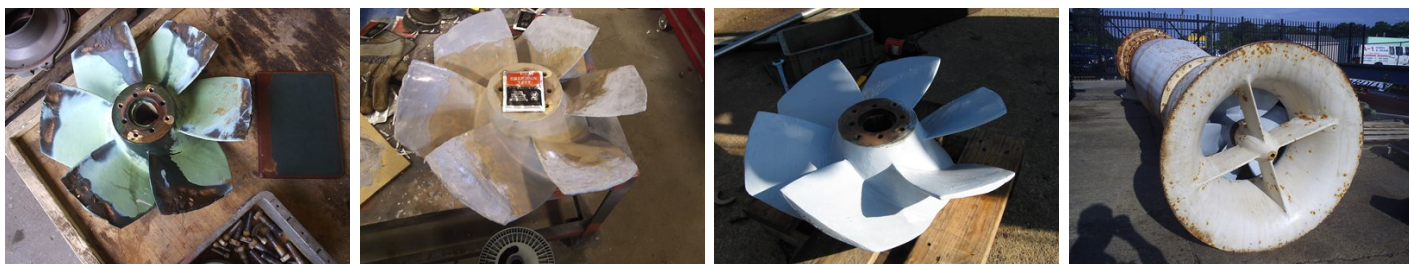
Impeller was damaged by cavitation leading to vibration in the pump. NSF approved products required.

- * Impeller showing Cavitation Damage ,
- * Impeller repaired with Belzona® 1221 ,
- * Impeller coated with Belzona® 1341N ,
- * Impeller installed into pump and ready for service ,

New impeller cost \$12,000 - \$14,000 with a 24 week lead time. Past experience proved brazing the bronze could lead to future metal failures. The Belzona repair is quick, low cost and effective solution. This application has been two years of service and is performing with out flaw.
