PROPELLER CAVITATION DAMAGE REPAIRED WITH BELZONA

ID: 1424

Industry: *Marine*
 Application: *SOS-Ships and Offshore Structures*

Customer Location: *Ship Dockyard, Bulgaria*
 Application Date: *June, 2008*

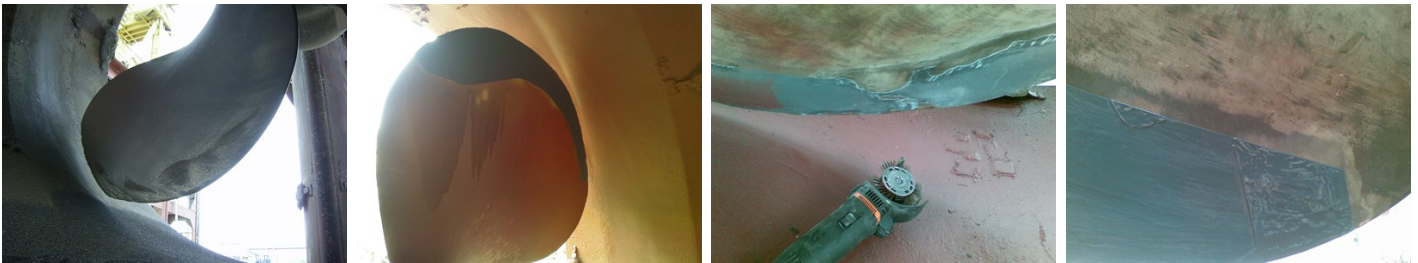
The cavitation damage close to the edges of the bronze propeller caused lower hydrodynamic efficiency and propulsion capabilities of the vessel.

- * The general view of cavitation damages after grit blasting ,
- * After rebuild with Belzona® 1311 two coats of Belzona® 1321 were applied ,
- * Inspection one year after the repair found some small mostly mechanical damage that were prepared by Bristle blasting ,
- * The damaged areas were corrected with Belzona® 1321 ,

The rebuild of cavitation damages by conventional welding and remachining were considered as too time consuming and required special skills to restore significant metal losses. The Belzona repair, in spite of being sacrificial, was chosen as more cost effective and time saving. After 1 year minor damage, mainly mechanical was found and locally repaired with further Belzona using an MBX
