BELZONA REPAIRS LEAKING FLANGE CONNECTION ON TRANSFORMER

ID: 1484

Customer Location: Electricity Distribution Company, UK
Application Date: 2006

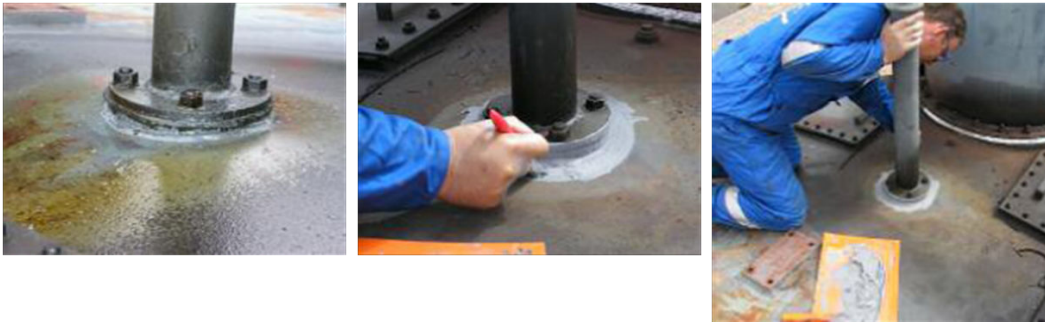
Oil leaking from flanged pipe connections

- * Oil leaking from flange ,
- * Belzona® 1161 being applied ,
- * Inspection of Belzona® 1161 application ,

Application was carried out in accordance with Belzona Know-How System Leaflet VPF-11a.

Repairs were carried out in-situ without the need to take the transformer off-line. Belzona® 1161 was applied without having to drain the transformer oil. Repair was total success.
