# BELZONA REPAIRS LEAKING FLANGE CONNECTION ON TRANSFORMER

ID: 1484

Customer Location: Electricity Distribution Company, UK  
Application Date: 2006

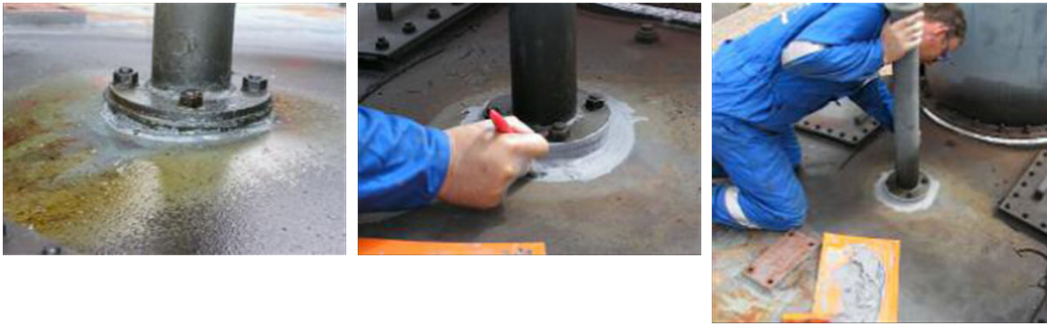
*Oil leaking from flanged pipe connections*

- \* Oil leaking from flange ,
- \* Belzona® 1161 being applied ,
- \* Inspection of Belzona® 1161 application ,

Repairs were carried out in-situ without the need to take the transformer off-line. Belzona® 1161 was applied without having to drain the transformer oil. Repair was total success.
