# BELZONA REPAIRS TRANSFORMER FLANGE OIL LEAK

ID: 1491

**Customer Location:** Arizona, USA  
**Application Date:** July 1992

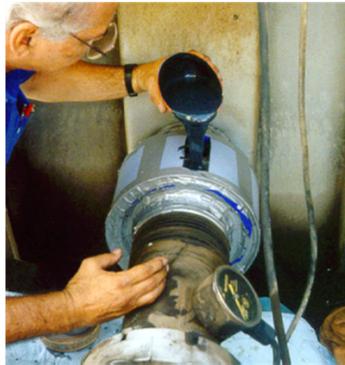
Oil leaks raised maintenance, EPA and safety concerns. Replacement of gaskets would require shut-down and dismantling of equipment.

- \* 1. Oil leak area of transformer ,
- \* 2. Seal with Belzona 1221, then pour Belzona 2221 encapsulated the flange ,
- \* 3. Application completed ,

The application was carried out in accordance with a modified of Belzona Know-How System Leaflet VPF-11 and GSS-4. Leaks were firstly stopped by using Belzona 1221. Mould was constructed and a fluid grade of Belzona 2221 was poured in to encapsulate the flange.
