BELZONA REPAIRS TRANSFORMER FLANGE OIL LEAK

ID: 1491

Flanged pipe connections on transformer flange at the major power company.

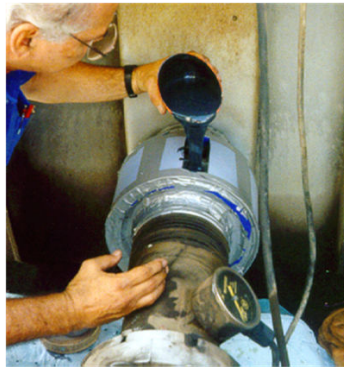
Oil leaks raised maintenance, EPA and safety concerns. Replacement of gaskets would require shut-down and dismantling of equipment.

- * 1. Oil leak area of transformer ,
- * 2. Seal with Belzona 1221, then pour Belzona 2221 encapsulated the flange ,
- * 3. Application completed ,

The application was carried out in accordance with a modified of Belzona Know-How System Leaflet VPF-11 and GSS-4. Leaks were firstly stopped by using Belzona 1221. Mould was constructed and a fluid grade of Belzona 2221 was poured in to encapsulate the flange.
