BELZONA® 2211 SEALS OIL LEAKS ON SWITCH RELAYS

ID: 151

Customer Location: Electricity Distribution, Western Australia

Earth bushings on an oil filled switching unit

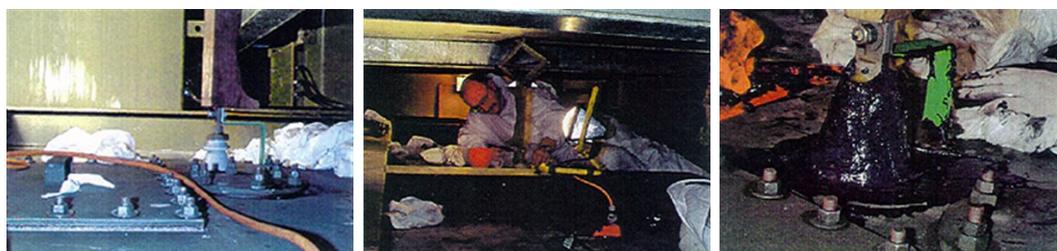
Up to five litres of oil per day were leaking through the bushings. Full repairs, working inside the reactor were deemed to contravene their Duty of Care, so alternatives were sought.

- * One of the leaking earth bushings ,
- * Work underway on the bushing (Note wedge in place to stem leak.) ,
- * Application of Belzona® 2211 complete ,

Application was carried out by encapsulating and sealing the leaking bushing to the surrounding metal. A jack between roof and bushing top was used to stem leak by compressing against cork gasket while the Belzona application is completed.

The repair was completed in 12 hours and cost just 6% of the quoted price to effect a full repair, that in any case could not be carried out for health and safety reasons.
