REPARACION DE BLOCK DE MOTOR

ID: 1624

Ubicación del cliente: Esen Generadores - Mar del Plata,
Argentina

Fecha de aplicación: Septiembre 2008

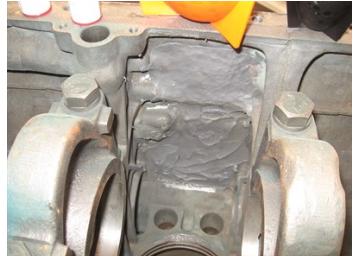
La rotura de una de las bielas del motor produjo la perforación del block del motor debido al fuerte impacto

Perforación de block de motor

La reparación fue realizada de acuerdo a lo establecido en las técnicas ENC-1 y ENC-11. Se utilizó refuerzo metálico y sucesivas capas de Belzona® 1111 y Belzona® 9341
