Mine locomotive axle repair

ID: 2457

Customer Location: *Brown coal Mine plant, Slovakia*
Application Date: *2005*

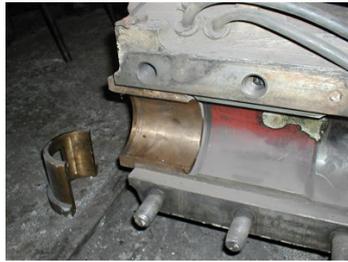
Failure of the shaft

Due the slide assembly wear of shaft axle in bronze bearing the shaft unloading appeared. Direct mark of this failure is big noise level.
