Mine locomotive axle repair

ID: 2457

Customer Location: *Brown coal Mine plant, Slovakia*
Application Date: *2005*

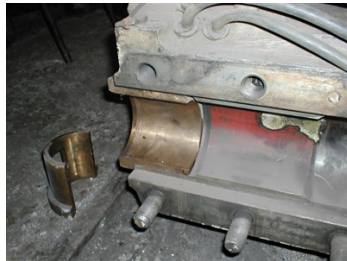
- * 1. Mine locomotive ,
- * 2. Failure bearing ,
- * 3. Repair in progress ,
- * 4. Renovated axle ,

Due the slide assembly wear of shaft axle in bronze bearing the shaft unloading appeared. Direct mark of this failure is big noise level.
