BELZONA PUMP REPAIR PROVIDES OVER TEN YEARS OF UNINTERRUPTED SERVICE

Application: *CEP-Centrifugal Pumps*

Customer Location: *Paper Company in Georgia*

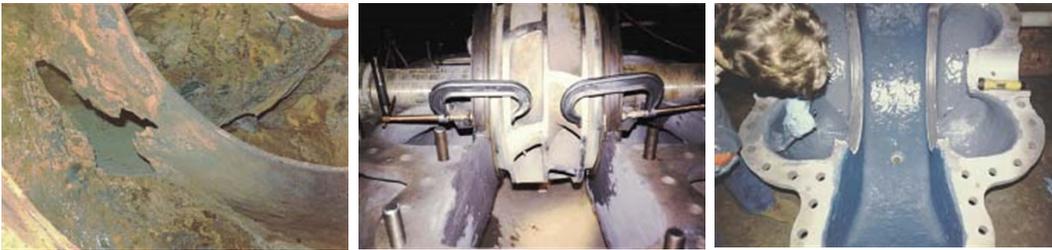
Pump suffered from erosion/corrosion and was completely destroyed after four years of operation

- * Severe damage ,
- * The wear ring seats rebuilt, clamps help ensure proper alignment ,
- * Belzona® 1321 (Ceramic S Metal) coating ,

Pump replacement cost is \$60,000.00. Cost of Belzona repair: \$9,300.00. After more than ten years of uninterrupted service, the pump is still in use and twice required only minor touch-ups. An impressive savings of three pump replacements.
