BELZONA PUMP REPAIR PROVIDES OVER TEN YEARS OF UNINTERRUPTED SERVICE

Industry: *Pulp & Paper*
Application: *CEP-Centrifugal Pumps*
Substrate: *Cast iron*
Products: ** Belzona® 1311 (Ceramic R Metal) ,*
** Belzona® 1321 (Ceramic S Metal) ,*

Customer Location: *Paper Company in Georgia*
Application Date: *November 1986*

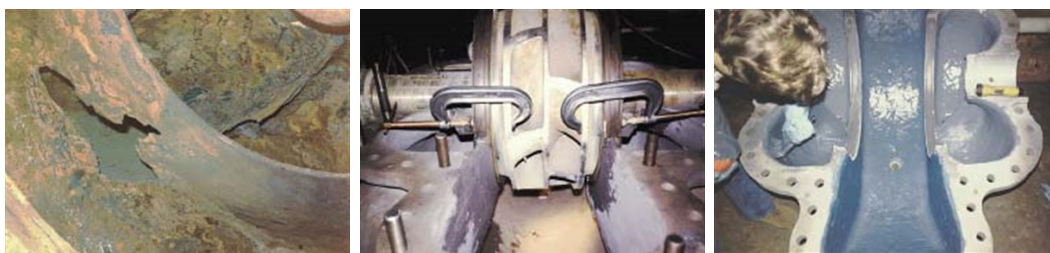
Pump suffered from erosion/corrosion and was completely destroyed after four years of operation

- * Severe damage ,
- * The wear ring seats rebuilt, clamps help ensure proper alignment ,
- * Belzona® 1321 (Ceramic S Metal) coating ,

The application was carried out in accordance with Belzona Know-How Leaflets CEP-1, CEP-2 and CEP-3.

Pump replacement cost is \$60,000.00. Cost of Belzona repair: \$9,300.00. After more than ten years of uninterrupted service, the pump is still in use and twice required only minor touch-ups. An impressive savings of three pump replacements.
