# BELZONA DIESEL ENGINE BLOCK RESTORED

ID: 32

Industry: *Marine*  
Application: *ENC-Engines and Casings*  
Substrate: *Cast steel*  
Products: *\* Belzona® 1111 (Super Metal) ,*

Customer Location: *Ship Repair Company in Florida*  
Application Date: *August 1995*

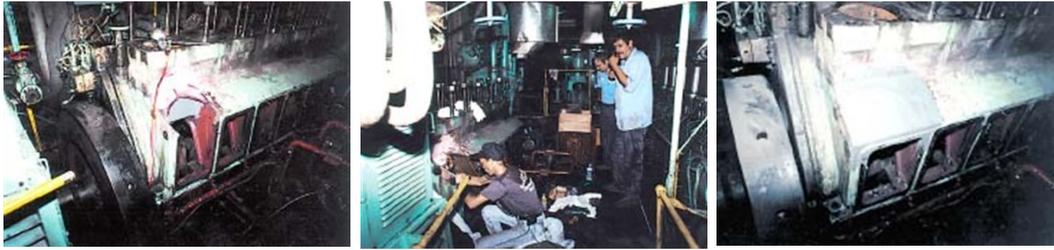
*Connecting rod went through the side of the casing, severely damaging the engine block*

\* Damaged engine block In the engine room, work in progress The finished repair ,

The application was carried out in accordance with a modified version of Belzona Know-How Leaflet ENC-1.
