BELZONA CAVITATION RESISTANCE FOR IMPELLER

ID: 33

Industry: *Oil & Gas*
Application: *CEP-Centrifugal Pumps*
Substrate: *Bronze*
Products: ** Belzona® 1311 (Ceramic R-Metal) ,*
** Belzona® 1421 ,*

Customer Location: *Oil Refinery in Mississippi*
Application Date: *August 1995*

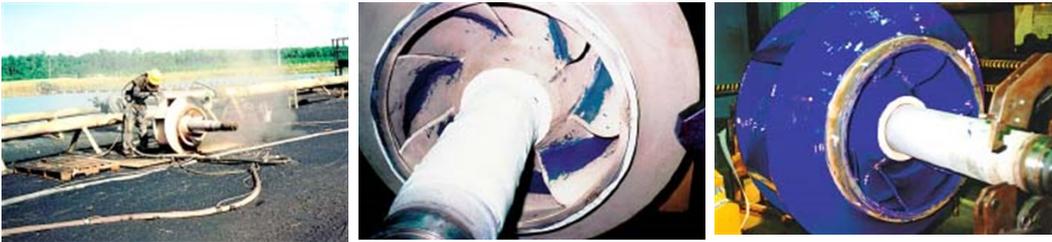
Severe damage to the impeller caused by cavitation

- * Surface preparation—abrasive grit blasting in progress ,
- * Cavitated areas of the impeller rebuilt with Belzona® 1311 ,
- * Application of Belzona® 1421 complete, impeller ready for service ,

40-inch impeller for cooling tower pump

The application was carried out in accordance with Belzona Know-How Leaflets CEP-1 and CEP-3.
