CAVITATION DAMAGE TO THIS TANKER PROPELLER REPAIRED WITH BELZONA

ID: 338

Customer Location: *Oil tanker in Argentina, South America*
Application Date: *April 1997*

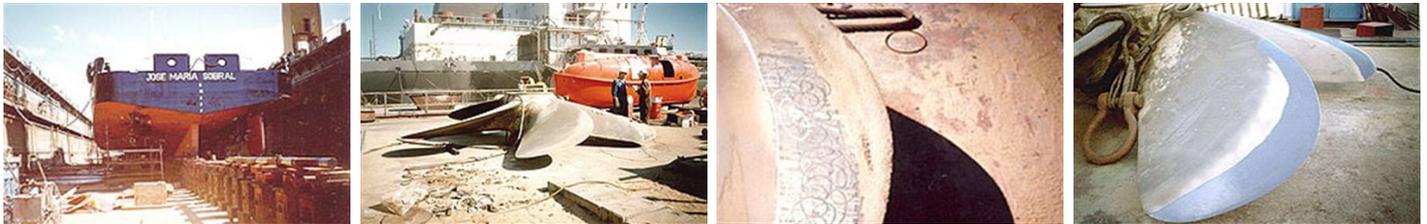
The large difference in pressure on the edges of this bronze propeller caused cavitation bubbles that in turn damaged the metal substrate after imploding onto the surface.

- * Aft view of the tanker ,
- * Surface preparation of the bronze propeller ,
- * Close up view of grinding profile ,
- * Finished application ,

Cavitation damage to a 12-foot diameter tanker propeller.

The application was carried out in accordance with Belzona Know-How System Leaflet SOS-2.

Any polymeric coating that is subject to cavitation will be sacrificial, how-ever it is a lot more cost effective than welding and remachining. It is very time consuming to braze bronze and requires skill to rebuild significant metal loss.
