CLASSIC BELZONA PUMP REFURBISHMENT-OUTPUT INCREASES 9.5% AFTER 3½ YEARS

ID: 363

Application: CEP-Centrifugal Pumps

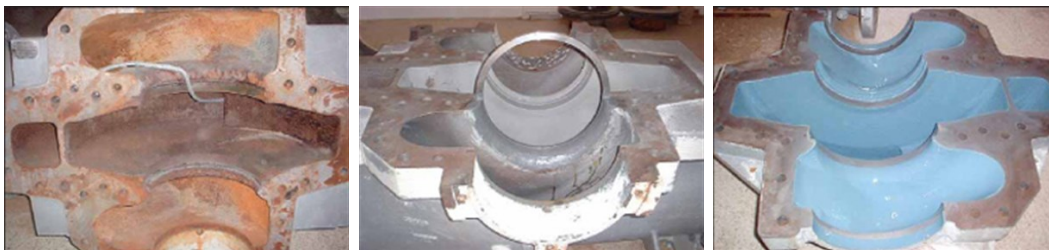
Output from the pumps was drastically reduced from the new condition due to corrosion and cavitation damage.

* Damaged pump Neck ring seats restored to original sizes Complete repair Coating in good condition after 3-1/2 years of service ,

Two badly corroded/cavitated centrifugal KSB water supply pumps.

Application was carried out in accordance with Belzona System Leaflets CEP-2 and CEP-10.

Flow rate of New Pump - 540 L/sec (142 gal/sec) Flow rate of damaged pump - 480 L/sec (126 gal/sec) Flow rate of repaired pump - 540 L/sec (142 gal/sec), an increase of more than 12% over the corroded pump. After 3-1/2 years, the flow rate of the repaired pump is 530 L/sec (140 gal/sec), an increase of more than 9.5% over the corroded pump.
