Rebuilding damaged overhead concrete

ID: 3823

Customer Location: Iron Ore Company, IRAN
Application Date: July 2012

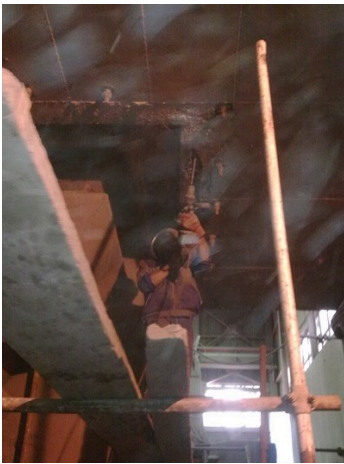
- * 1. Removing damaged concrete ,
- * 2. Damaged area and showing round bars ,
- * 3. and 4. Completed repair ,

Application carried out in accordance with the Belzona Know-How system leaflet RPA-2 and the selected Belzona 4141 mixed and applied in accordance with the relevant Instruction For Use. Overhead concrete structure has extensive areas of damage created by crack and water leakage and affects the round bars. Application of Belzona 4141 as a lightweight repair system, would protect round bar and reinforce the cracks.

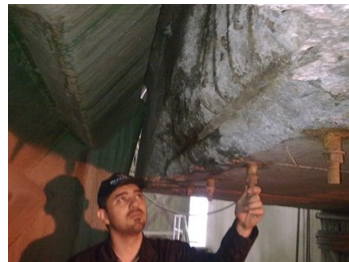
Due to the existence of crack in the concrete structure and ingress of water in the cracks, some area of concrete gets part and the round bars are corroded with expose to water and air.
