Rebuilding damaged overhead concrete

ID: 3823

Customer Location: Iron Ore Company, IRAN
Application Date: July 2012

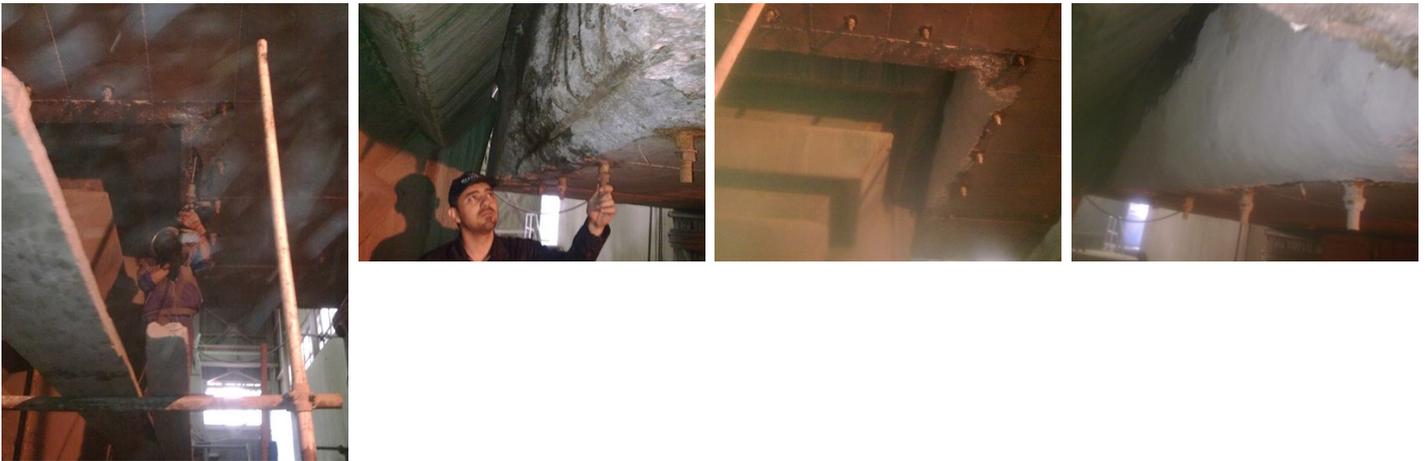
Due to the existence of crack in the concrete structure and ingress of water in the cracks, some area of concrete gets part and the round bars are corroded with expose to water and air.

- * 1. Removing damaged concrete ,
- * 2. Damaged area and showing round bars ,
- * 3. and 4. Completed repair ,

Application carried out in accordance with the Belzona Know-How system leaflet RPA-2 and the selected Belzona 4141 mixed and applied in accordance with the relevant Instruction For Use. Overhead concrete structure has extensive areas of damage created by crack and water leakage and affects the round bars. Application of Belzona 4141 as a lightweight repair system, would protect round bar and reinforce the cracks.
