BELZONA REPAIRS VENT GAS PIPEWORK

ID: 383

Customer Location: North Sea gas producer

3" pipespool on gas platform vent system.

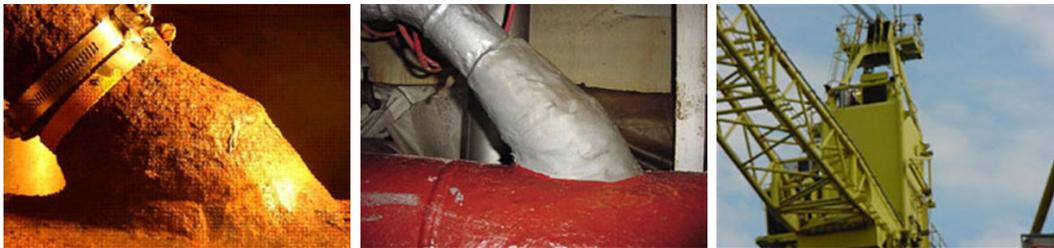
External corrosion had led to severe wall thinning in numerous parts of the pipework. In addition several areas were holed and were being contained with a temporary fix. The welded nature of the pipework would have made replacement of the pipespool impossible as the vent gas pipework forms part of the platform's safety system.

- * Vent gas pipework showing severe corrosion ,
- * Completed repair ,
- * Platform crane's radiator was the site of several other Belzona pipe repairs ,

During a recent platform shutdown the temporary repair was removed and the pipe and surrounding areas were cleaned by grit blasting. Belzona® 1111 was applied to the area and Belzona® 9341 wrapped around the pipe to prevent further deterioration of the corroded area.

This was pressure tested to the design pressure of the system before allowing gas back into the system. All tests were successfully completed.
