BELZONA REPAIRS CRACKED GEARBOX

ID: 4219

Customer Location: Quarry, Cambridge, UK
Application Date: October 2012

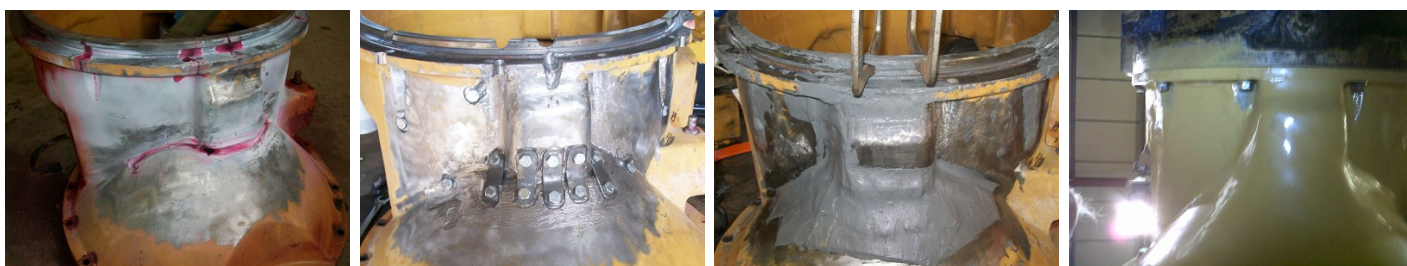
The workshop tried to repair this crack by welding it but when the weld cooled down the crack reopened and also created more cracks in the gearbox casing. Quarry contacted Belzona for an alternative solution.

* Cracks in gearbox marked in red Gearbox prepared by workshop Belzona® 1111 being applied Completed repair with gearbox repainted and fitted to engine 2 days later ,

Gearbox from CAT 966G loader was dropped from crane during routine maintenance causing large crack.

Application was carried out in accordance with Belzona Know-How System Leaflet ENC-1. After drilling and tapping ends of all cracks to "blind" them steel straps were bolted across the vee'd out cracks before sealing with Belzona® 1111 incorporating Belzona® 9341 (Reinforcement Tape). Finally the repair was smoothed and painted.
