BELZONA REPAIRS CRACKED GEARBOX

ID: 4219

Industry: *Mining & Quarrying*
Application: *ENC-Engines and Casings*
Substrate: *Cast steel*
Products: ** Belzona® 1111 (Super Metal) ,*

Customer Location: *Quarry, Cambridge, UK*
Application Date: *October 2012*

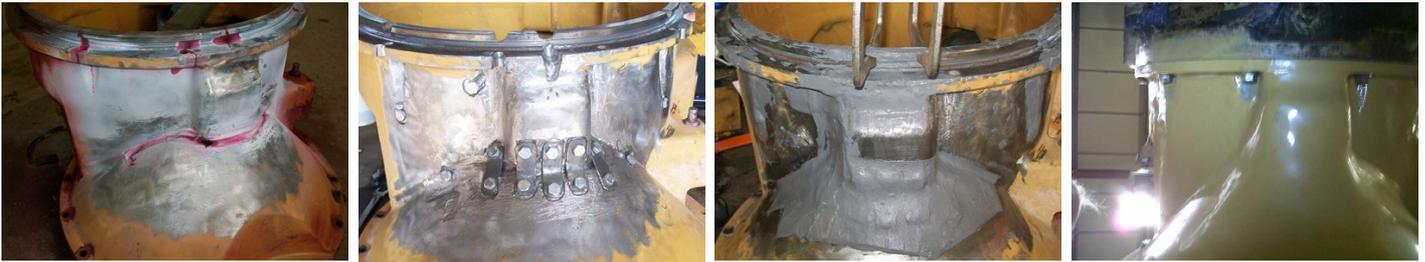
The workshop tried to repair this crack by welding it but when the weld cooled down the crack reopened and also created more cracks in the gearbox casing. Quarry contacted Belzona for an alternative solution.

* Cracks in gearbox marked in red Gearbox prepared by workshop Belzona® 1111 being applied Completed repair with gearbox repainted and fitted to engine 2 days later ,

Gearbox from CAT 966G loader was dropped from crane during routine maintenance causing large crack.

Application was carried out in accordance with Belzona Know-How System Leaflet ENC-1. After drilling and tapping ends of all cracks to "blind" them steel straps were bolted across the vee'd out cracks before sealing with Belzona® 1111 incorporating Belzona® 9341 (Reinforcement Tape). Finally the repair was smoothed and painted.
