# THERE'S NOTHING FISHY ABOUT THIS BELZONA REPAIR

ID: 430

Application: *ENC-Engines and Casings*

Cracked engine block

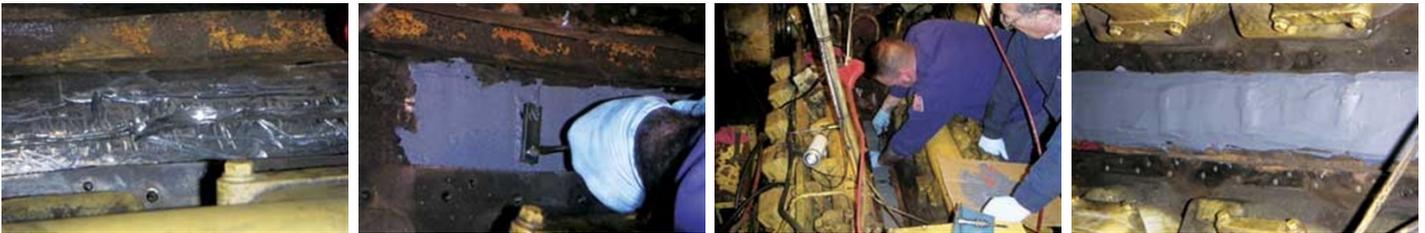
*Cooling water froze due to lack of anti-freeze causing the engine block to crack.*

- \* Engine block after surface prep. ,
- \* Belzona® 1111 applied. Metal bars are used to stabilize crack. ,
- \* Installing metal bars. ,
- \* More Belzona® 1111 applied to cover and protect the metal bars. Job completed. ,

Weld repairs were rejected due to concerns about heat stress. Quick turn around was important due to lost production while boat was in port.
