BELZONA REPAIRS CONVEYOR DRIVE SHAFT IN-SITU

ID: 448

Customer Location: *Cement works in Egypt*
Application Date: *September 2003*

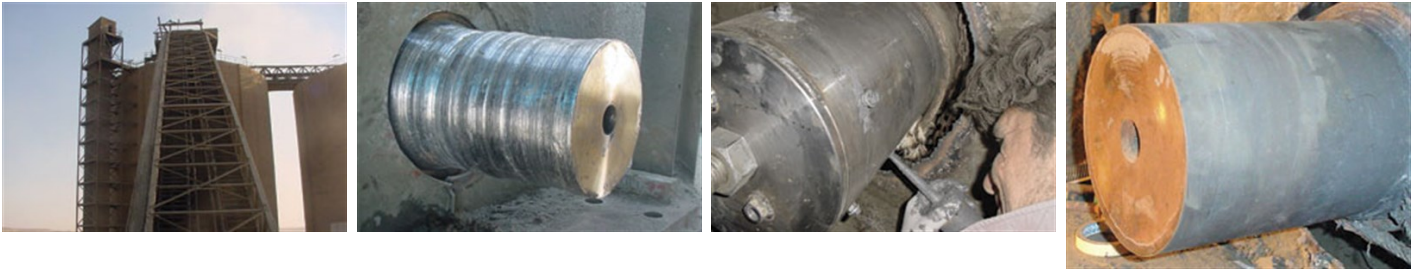
Drive shaft was badly worn due to incorrect tightening of the adjustable sleeve which leads to relative motion between the shaft and the sleeve.

- * General view of the elevator lifting clinker into silos ,
- * Damage to the shaft ,
- * Former in place and Belzona® 1311 being injected ,
- * Accurate diameter restored to the shaft ,

Belzona® 1311 was injected, using pneumatic injection pistol, into former constructed to restore correct shaft diameter. The Belzona repair was carried out without need to remove shaft from the plant saving many days work.
