BELZONA REPAIRS BROKEN HYDRO ELECTRIC TURBINE RUNNER

ID: 4674

Customer Location: Hydro Electric Plant, USA

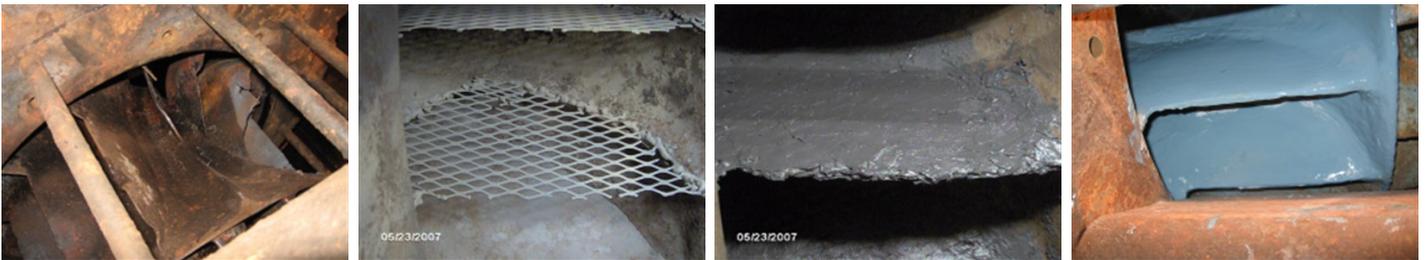
Loss of balance and horsepower.

* Broken runner blade Expanded metal tack welded Blades rebuilt with Belzona® 1311 Completed application after coating runner ,

Wicket gate came loose and fell into turbine breaking three blades on runner.

Application was carried out in accordance with the Belzona Know-How System Leaflets CEP-1 & CEP-3. Expanded metal was tack welded in place before rebuilding with Belzona® 1311. Complete runner was coated with Belzona® 1311 and Belzona® 1341 was applied on top to improve fluid flow efficiency.
