BELZONA REPAIRS BROKEN HYDRO ELECTRIC TURBINE RUNNER

ID: 4674

Customer Location: *Hydro Electric Plant, USA*

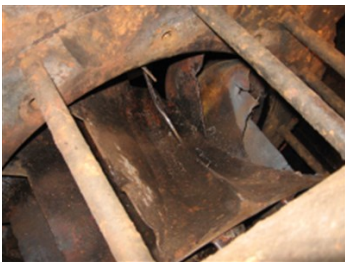
* Broken runner blade Expanded metal tack welded Blades rebuilt with Belzona® 1311 Completed application after coating runner ,

Wicket gate came loose and fell into turbine breaking three blades on runner.

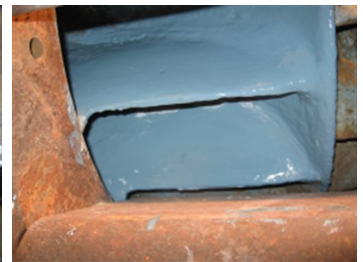
The efficiency gain was so profound, that the customer was able to reduce the water setting from 70% to 62% without changing the power output from the runner, maintaining the 500 kW output. Using less water, the water behind the dam lasts longer, keeps the turbine running longer, resulting in increased revenue across a year. Belzona solution cost 9.2% of the conventional replacement by repairing the turbine instead of tearing it down and sending it out to be repaired. While the conventional repair would take 10 weeks of downtime, Belzona refurbishment took 2 weeks. The customer's payback period on this repair was 3 months. Three years later and the turbines still have good horsepower with the runner blades still intact.
