BELZONA REINFLATES FENDER

ID: 4806

Industry: Marine
Application: SOS-Ships and Offshore Structures

Customer Location: Dredging company, Abu Dhabi, U.A.E.
Application Date: October 2013

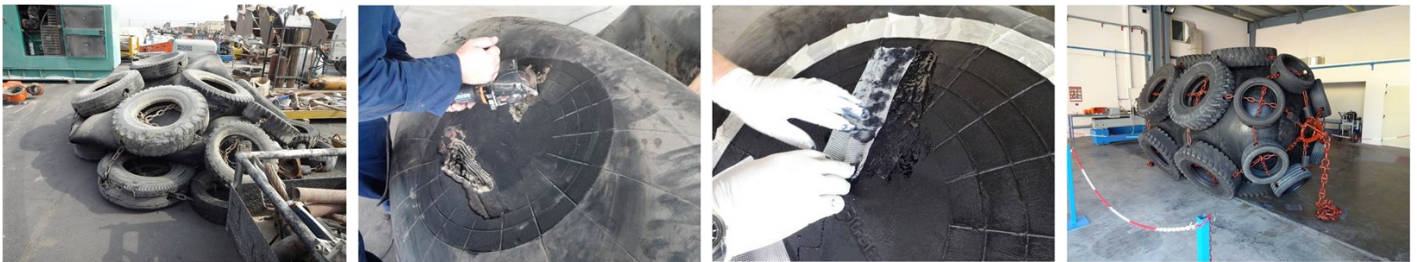
Although wrapped with tyres on chains to help protection, the fenders were in need of a full service or replacement. Punctures had deflated the fenders rendering them useless.

- * Initial inspection of deflated fender ,
- * Stitching of punctures ,
- * Application of Belzona 2111 incorporating ,
- * Reinforcement tape Finished application ,

Application was carried out in accordance with Belzona Know-How System Leaflet SOS-12. Surfaces were prepared using a power wire brush. Punctures were stitched together using Nylon thread. After Conditioning the areas were rebuilt with Belzona 2111 incorporating Belzona 9341 (Reinforcement Tape).
