# BELZONA REPAIRS NEW FLOATING HOSE SECTION DAMAGED IN TRANSIT

ID: 4818

Customer Location: Oil company, North Sea, UK  
Application Date: November 2011

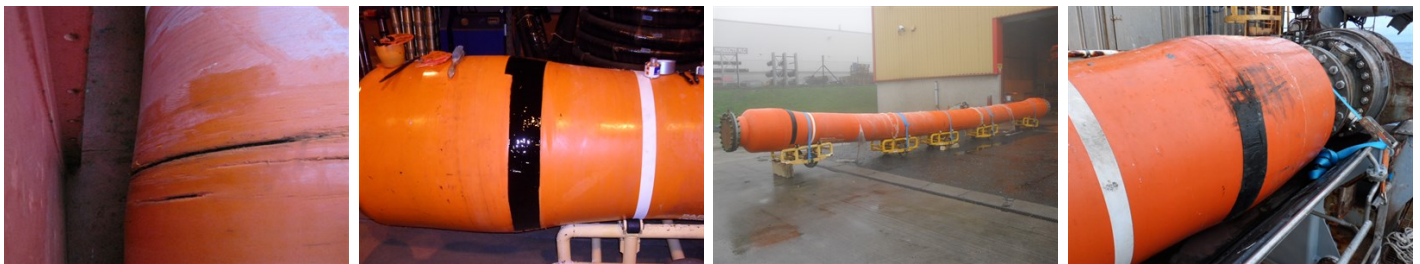
Hose had been damaged in transit as a result of its fastenings coming loose. The hose had rubbed against its container frame.

\* 1. 15mm deep cuts in the floating hose cover 2. Application of reinforced system of Belzona 2211 3. Completed Belzona repair 4. Inspection of the hose 2 years later showing the Belzona application still in service ,

Application was carried out in accordance with Belzona System Leaflet SOS-12. The surface of the hose was roughened prior to application of Belzona 2911 (QD Conditioner) followed by a reinforced system of Belzona 2211 to the damaged areas.
