# BELZONA REPAIRS NEW FLOATING HOSE SECTION DAMAGED IN TRANSIT

ID: 4818

Industry: Oil & Gas  
Application: SOS-Ships and Offshore Structures

Customer Location: Oil company, North Sea, UK  
Application Date: November 2011

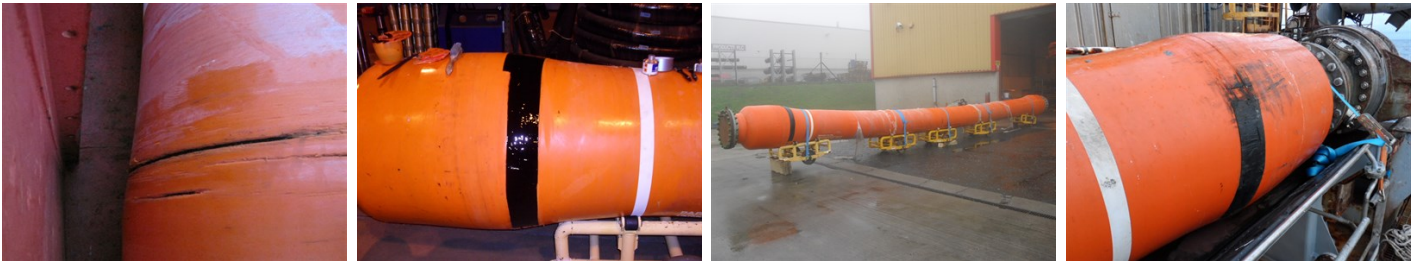
*Hose had been damaged in transit as a result of its fastenings coming loose. The hose had rubbed against its container frame.*

\* 1. 15mm deep cuts in the floating hose cover 2. Application of reinforced system of Belzona 2211 3. Completed Belzona repair 4. Inspection of the hose 2 years later showing the Belzona application still in service ,

Application was carried out in accordance with Belzona System Leaflet SOS-12. The surface of the hose was roughened prior to application of Belzona 2911 (QD Conditioner) followed by a reinforced system of Belzona 2211 to the damaged areas.
