# REPAIR OF MOTOR BLOCK OF 789 MINING TRUCK

ID: 4868

Customer Location: Mine, Chile  
Application Date: January 2005

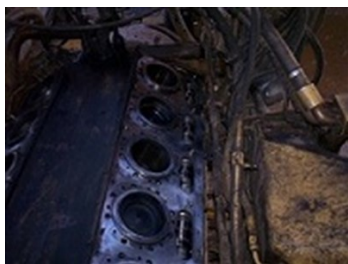
The engine was corroded and presented a problem in the filtration area where water flows from the engine block
