BELZONA RESTORES DAMAGED CLUTCH ON DREDGER

ID: 4971

Industry: *Mining & Quarrying*
Application: *SHM-Solids Handling Machinery*

Customer Location: *Gravel pit, Croatia*
Application Date: *April 2013*

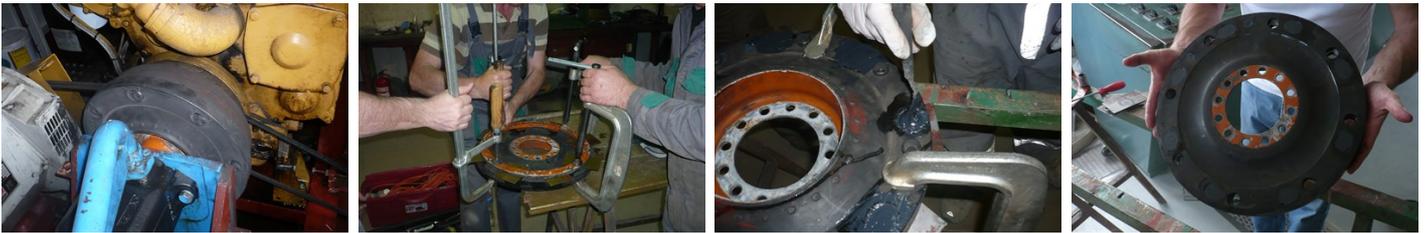
Rubberized clutch suffered damage during operation of the engine. The holes became deformed and the clutch was no longer performing as needed.

- * Damaged clutch in its original position ,
- * Metal plates treated with Belzona 9411 and fastened to seal one side of every hole ,
- * Filling previously prepared and conditioned holes with Belzona 2211 ,
- * Application completed. Old holes sealed and new ones drilled ,

Application was carried out in accordance with a modified version of Belzona System Leaflet SHM-9. Metal plates treated with Belzona 9411 (Release Agent) were used to form the Belzona Elastomer. Damaged holes were reformed with Belzona Elastomer before being re-drilled in new locations.
