BELZONA REPAIRS CRUSHER'S ADJUSTMENT RING

ID: 5087

Industry: Mining & Quarrying

Customer Location: Mine, Chile

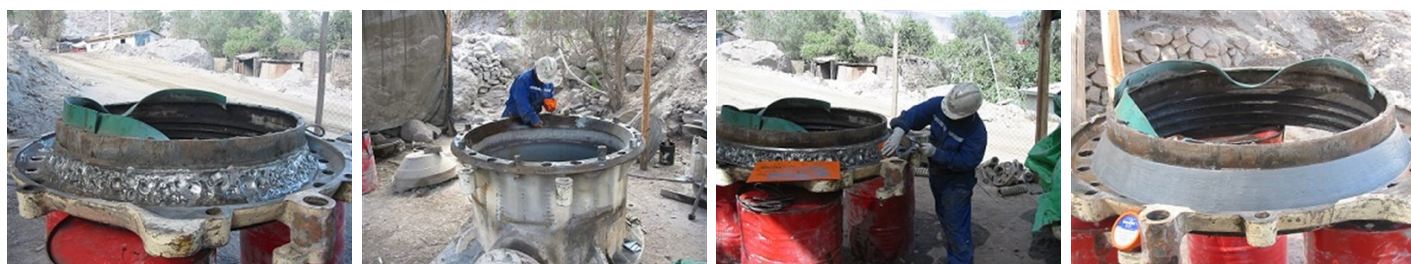
The worn-out strip prevented the crusher from functioning well.

- * Damage on the ring of the crusher ,
- * Application of Belzona 9411 on the surface of the crusher ,
- * Application of Belzona 1111 on the strip of the worn-out ring ,
- * The ring repaired with Belzona 1111 ,

First, the surface was prepared with emery cloth. Afterwards, Belzona 9411 was applied to the surface of the crusher in order to later apply Belzona 1111 to the worn-out ring and join the pieces together to mold Belzona 1111 between the two pieces.
