# BELZONA REBUILDS DAMAGED PUMP FLANGE

ID: 5193

Industry: *Mining & Quarrying*  
Application: *FPA-Floor Problem Areas*  
Substrate: *Cast Iron*  
Products: *\* Belzona 1311 (Ceramic R Metal) ,*

Customer Location: *BC, Canada*  
Application Date: *February 2004*

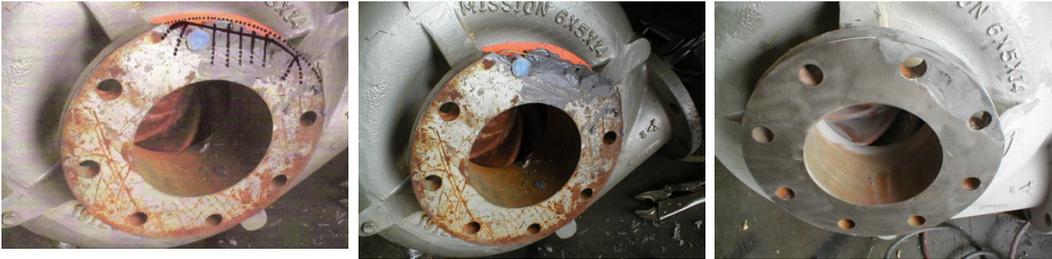
*The cast iron pump casing had fallen of a pallet breaking part of the flange.*

- \* Diagram showing support cage fabricated for the damaged area ,
- \* Rebuilding in progress ,
- \* Rebuilt flange ,

Broken flange on pump

After tapping a number of holes along the broken flange edge, a reinforcement cage was bonded into place around the edge using a welding rod to provide some structural integrity to the area to be rebuilt. Once in place the various pieces were tack welded together.
