BELZONA REBUILDS DAMAGED PUMP FLANGE

ID: 5193

Customer Location: *BC, Canada*
Application Date: *February 2004*

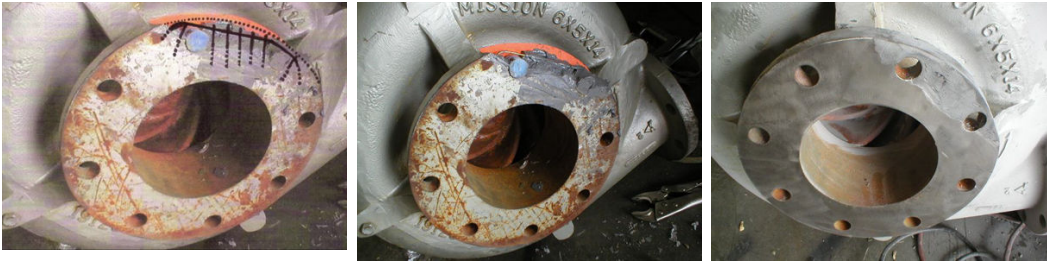
The cast iron pump casing had fallen of a pallet breaking part of the flange.

- * Diagram showing support cage fabricated for the damaged area ,
- * Rebuilding in progress ,
- * Rebuilt flange ,

After tapping a number of holes along the broken flange edge, a reinforcement cage was bonded into place around the edge using a welding rod to provide some structural integrity to the area to be rebuilt. Once in place the various pieces were tack welded together.
