BELZONA REBUILDS DAMAGED PUMP FLANGE

ID: 5193

Industry: Mining & Quarrying

Application: FPA-Floor Problem Areas

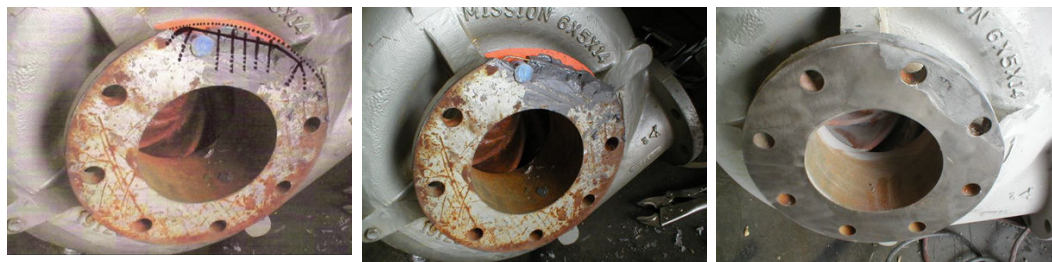
The cast iron pump casing had fallen off a pallet breaking part of the flange.

- * Diagram showing support cage fabricated for the damaged area ,
- * Rebuilding in progress ,
- * Rebuilt flange ,

After tapping a number of holes along the broken flange edge, a reinforcement cage was bonded into place around the edge using a welding rod to provide some structural integrity to the area to be rebuilt. Once in place the various pieces were tack welded together.
