# BELZONA REPAIRS ROOF LEAK

ID: 5259

Customer Location: Washington, USA  
Application Date: 1984

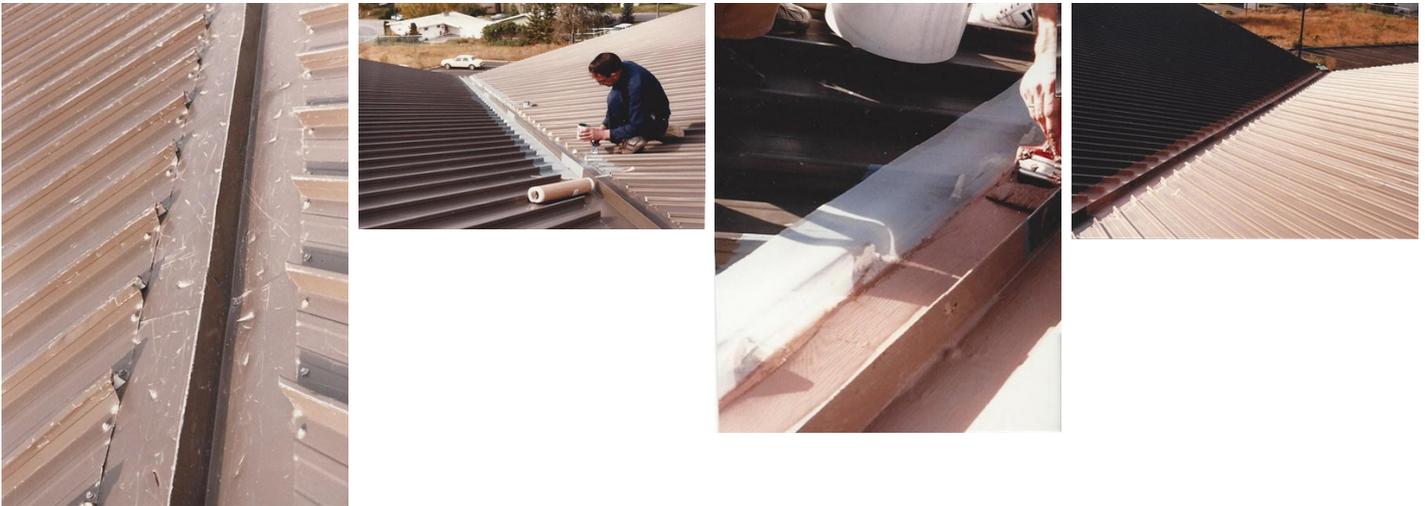
Continual ice build up in the valley forced water under the roof panels due to poor roof design, causing leaks. Someone decided to remove the ice with an ax, causing holes and more leaks.

- \* Valley flashing showing ax holes ,
- \* Brushing on Belzona 3921 ,
- \* First coat of Belzona 3111 with reinforcing sheet ,
- \* Completed application ,

The flashing was properly cleaned and abraded. Belzona 3921 was brushed on followed by two coats of Belzona 3111 being applied

with Belzona 9311, which was laid onto the substrate. The application was carried out in accordance with Belzona Know-How System Leaflet RPA-8.
