# BELZONA REPAIRS ROOF LEAK

ID: 5259

Industry: Buildings & Structures  
Application: RPA-Roof Problem Areas  
Substrate: Steel  
Products: \* Belzona 3111 (Flexible Membrane) ,  
\* Belzona 3921 (GSC Surface Conditioner) ,  
\* Belzona 9311 (Reinforcing Sheet) ,  
\* ,

Customer Location: Washington, USA  
Application Date: 1984

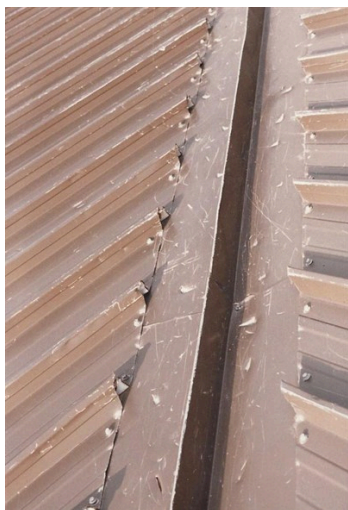
Continual ice build up in the valley forced water under the roof panels due to poor roof design, causing leaks. Someone decided to remove the ice with an ax, causing holes and more leaks.

- \* Valley flashing showing ax holes ,
- \* Brushing on Belzona 3921 ,
- \* First coat of Belzona 3111 with reinforcing sheet ,
- \* Completed application ,

The flashing was properly cleaned and abraded. Belzona 3921 was brushed on followed by two coats of Belzona 3111 being applied

with Belzona 9311, which was laid onto the substrate. The application was carried out in accordance with Belzona Know-How System Leaflet RPA-8.
