BELZONA REPAIRS ENGINE BLOCK

ID: 5264

Industry: *General Industry*
Application: *ENC-Engines and Casings*
Substrate: *Cast Iron*
Products: ** Belzona 1111 (Super Metal) ,*

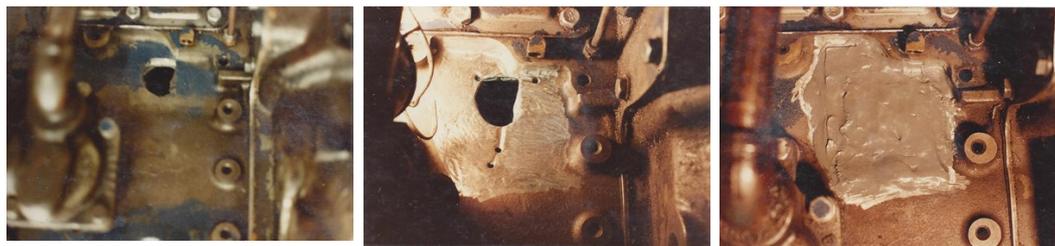
A hole in the engine block allowed the oil to leak out.

- * The engine block showing the hole ,
- * The cracks have been stabilized by drilling the extremities ,
- * A plate was bonded over the hole using Belzona 1111 ,

A broken connecting rod went through the block. The owner replaced the rod but did not know what to do about the hole. Belzona repaired the hole, solving the problem for the owner.

After proper surface preparation the application was carried out in accordance with Belzona Know-How System Leaflet ENC-1.
