# BELZONA REPAIRS ENGINE BLOCK

ID: 5264

Industry: *General Industry*  
Application: *ENC-Engines and Casings*  
Substrate: *Cast Iron*  
Products: *\* Belzona 1111 (Super Metal) ,*

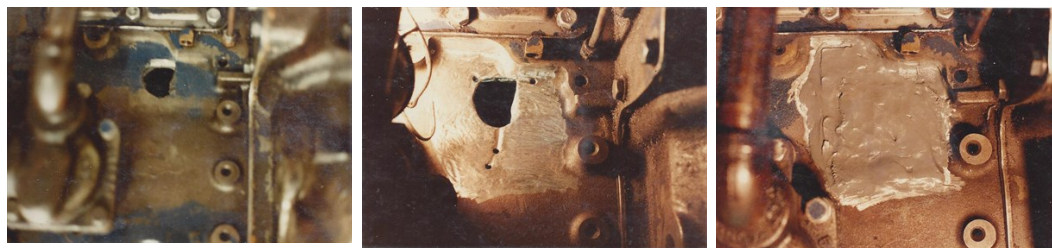
*A hole in the engine block allowed the oil to leak out.*

- \* The engine block showing the hole ,
- \* The cracks have been stabilized by drilling the extremities ,
- \* A plate was bonded over the hole using Belzona 1111 ,

A broken connecting rod went through the block. The owner replaced the rod but did not know what to do about the hole. Belzona repaired the hole, solving the problem for the owner.

After proper surface preparation the application was carried out in accordance with Belzona Know-How System Leaflet ENC-1.
