BELZONA REPAIRS CRACK ON ENGINE BLOCK

ID: 5270

Industry: *Pulp & Paper*
Application: *ENC-Engines and Casings*
Substrate: *Cast Iron*
Products: ** Belzona 1111 (Super Metal) ,*
** Belzona 9341 (Reinforcing Sheet) ,*

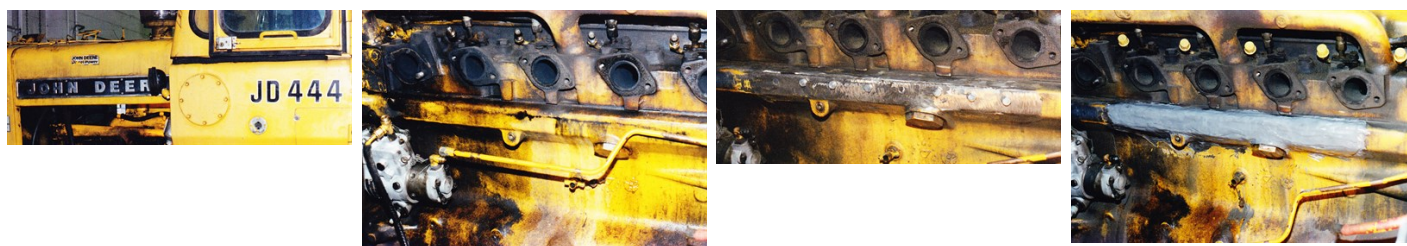
An early freeze allowed ice to crack the engine casing.

- * JD 444 Loader with cracked engine block ,
- * Engine showing long crack in water jacket ,
- * Area prepared with studs in place ,
- * Completed application ,

Cracked engine casing leaks antifreeze.

The application was carried out in accordance with Belzona Know-How System Leaflet ENC-1. The area was ground, studs placed every 2 inches then covered with Belzona 1111, incorporating Belzona 9341.
